Project: 20019

July 3, 2020

Re: Hansen Park (Cherryville Park) on Cherry Creek, 127 North Fork Road – Flood Protection and Damage Assessment

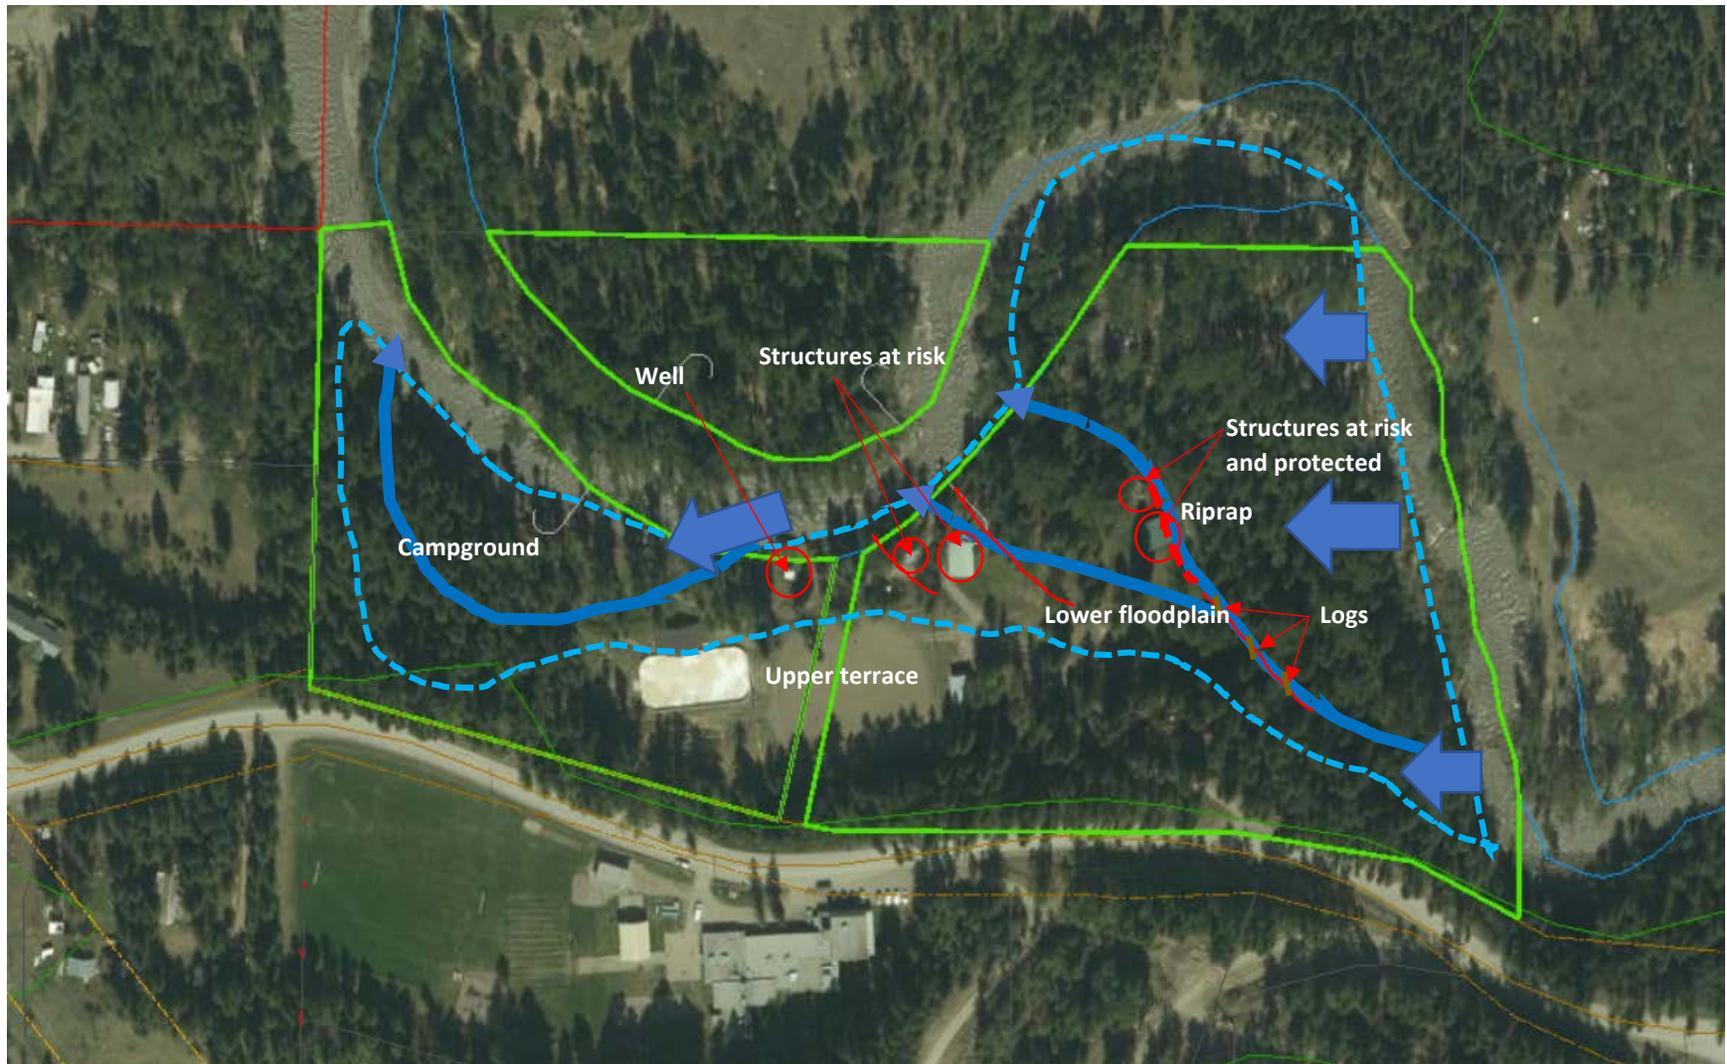
floodplain as illustrated in Figure 2. The area within the dashed blue line is the lower floodplain that was inundated by the floodwaters. The blue arrows illustrate the main overflow paths. The upstream flow path includes a defined highwater channel that concentrated flows towards the stage and adjacent concession. The downstream flow path, downstream of the well, is also an old highwater channel but less well defined and conveyed overflow through the campground area.

The ditching done across the floodplain, west of the highwater channel, (shown in Photo 7 and as red lines in Figure 2), had little to no effect on reducing the overland flow towards the campground.

The lower floodplain, adjacent to the left bank of Cherry Creek, as outlined in Figure 2, is highly susceptible to flooding during high flows in the creek.

There was general overland flooding of the areas shown in Figure 2 that threatened the covered dining area and the concession building to the west and the well. The floodwaters deposited a layer of mud wherever it flowed across the floodplain.

Figure 2 – Cherryville Park Flooding during May 2020 high flows in Cherry Creek. [Area within blue dashed polygon is lower floodplain]

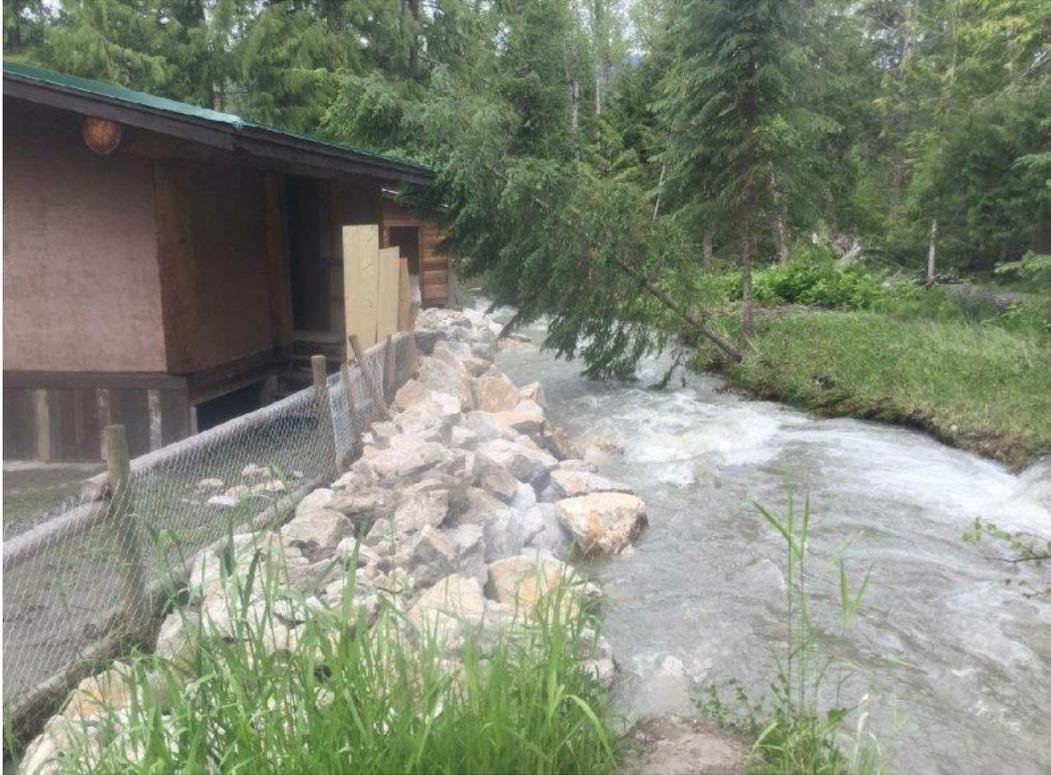
The emergency works undertaken by the community during the flood event included placement of logs along the left bank of the upstream highwater channel (Photos 3&4) and large riprap along a section of the left bank behind the two structures (Photo 1). Overflow from the upstream highwater channel flowed across the floodplain surrounding the structures and the well (Photos 5&6). Shallow diversion ditches with low berms, (Photo 2 and red lines on Figure 2), were constructed across the floodplain to divert floodwaters away from the structures and back to the creek.

The emergency works constructed in May are not considered to be permanent works. The riprap that was placed behind the two structures during the high flows in the highwater channel is not keyed-in to the channel bed or the banks (Photo 1). Although it did prevent the loss of the structures, if it was to be used for permanent protection, it would have to be removed and reinstalled properly.

The placement of the riprap in the highwater channel would likely be deemed to cause harmful alteration, disruption or destruction of fish habitat, section 35(1) of the Fisheries Act [<https://laws-lois.justice.gc.ca/eng/acts/f-14/FullText.html>]. Similarly, the disturbances along the highwater channel where the logs were placed to divert flows would also likely be a contravention of Section 35(1) of the Act. The construction of the diversion ditches within 30m of the stream is considered to be within the riparian area that is considered to be fish habitat. Even though this is previously disturbed land, the ditching has contributed sediment to the creek and that may also be deemed a contravention of Section 35(1).

Photo 1 – Emergency riprap in highwater channel behind stage and concession

- a. Remove the riprap and restore the disturbed bank and channel where the riprap was placed.
- b. Remove the logs placed along the left bank of the highwater channel upstream of the riprap.
- c. Restore the access trail constructed along the left bank of the highwater channel to prevent further sediment delivery to the stream.
- d. Restore the diversion ditches across the floodplain west of the highwater channel to prevent further sediment delivery to Cherry Creek.

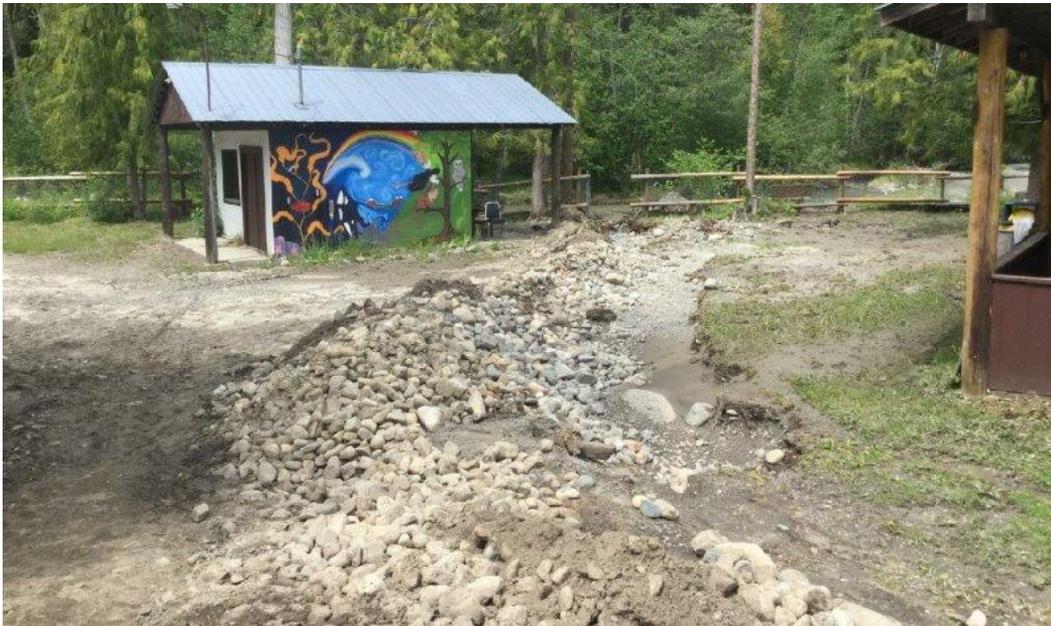
During a high flow event in Cherry Creek in late May 2020 some emergency flood protection works were undertaken by the local community to protect vulnerable infrastructure in the park near Cherry Creek (Photos 1&2). The emergency works were not designed or authorized prior to installation and were installed within a highwater channel and also on the floodplain within the riparian area.

Photo 2 – Emergency ditching and berms near closed concession building

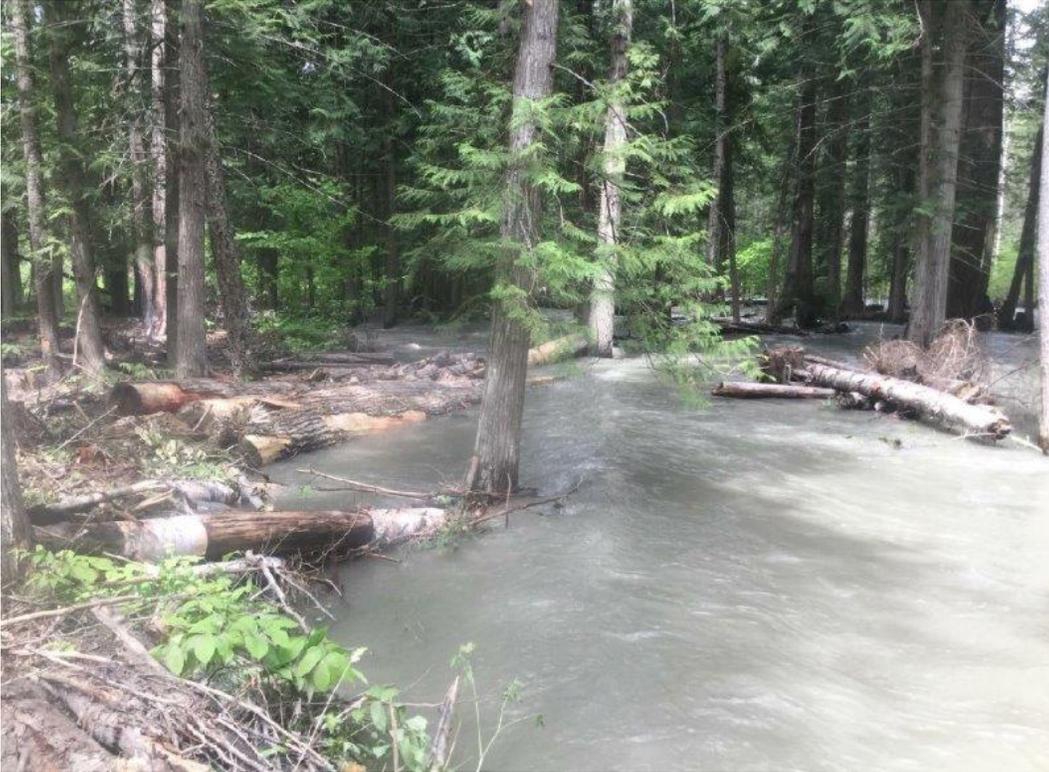
The logs that were placed along the left bank of the highwater channel, upstream of the riprap, may have diverted some flows back towards the main channel but at very high flows, as were experienced in May, they would have been overwhelmed and had little effect.

Photo 3 – Logs placed in highwater channel to divert flows

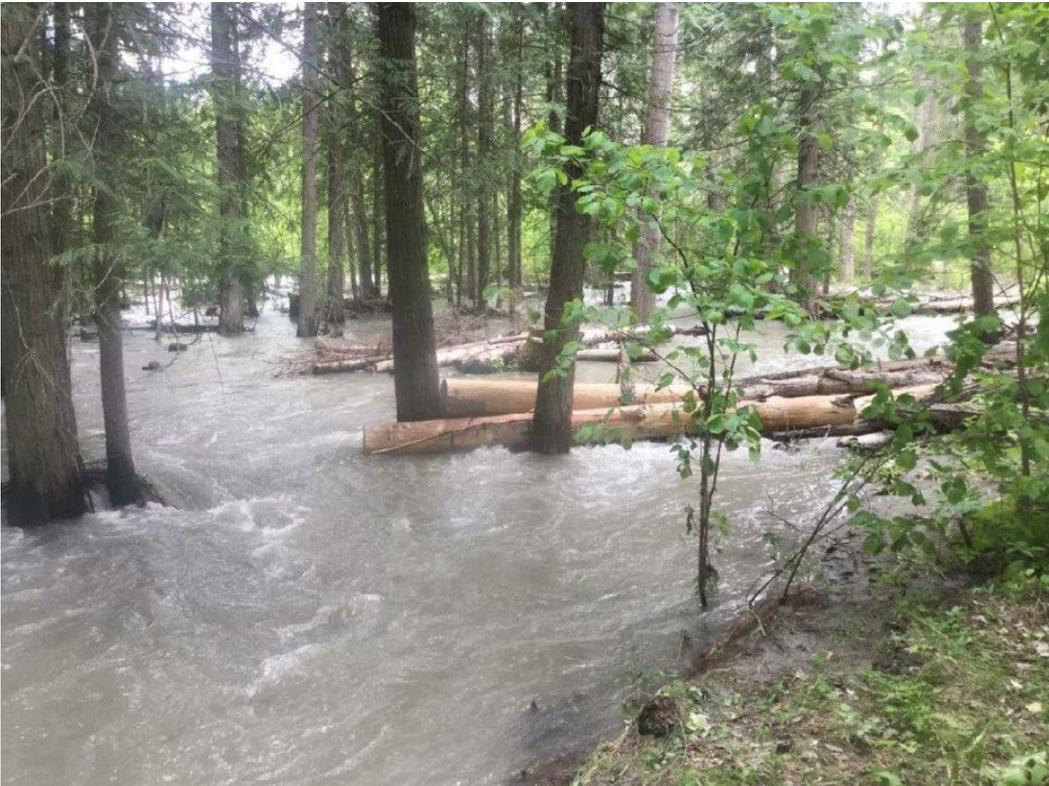
Photo 4 – Logs placed in highwater channel to divert flows

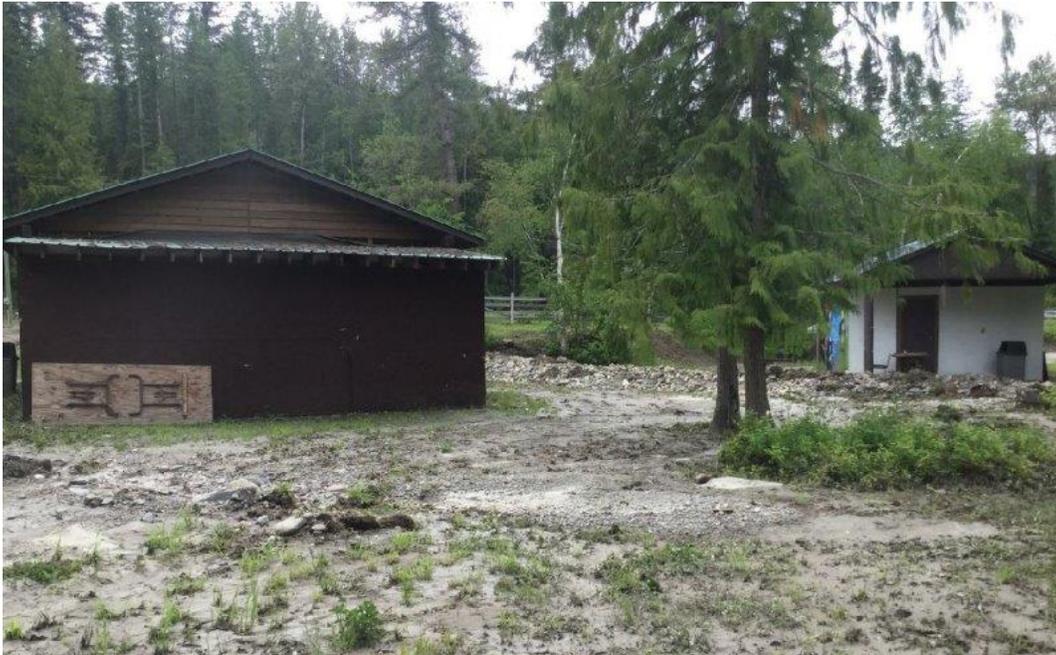
Photo 5 – Floodwater impacts on lower floodplain

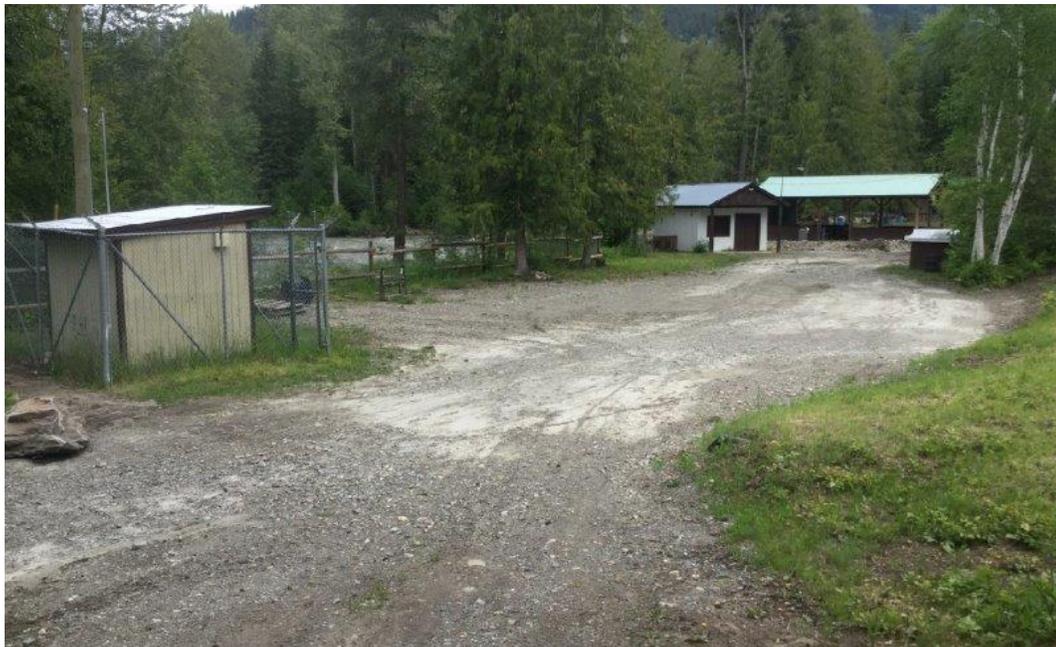
Photo 6 – Evidence of floodwaters surrounding well building

- The closed concession and the toilet should be removed from the lower floodplain.
- The well building should be elevated and floodproofed.
- The water intake works by the well should be floodproofed.

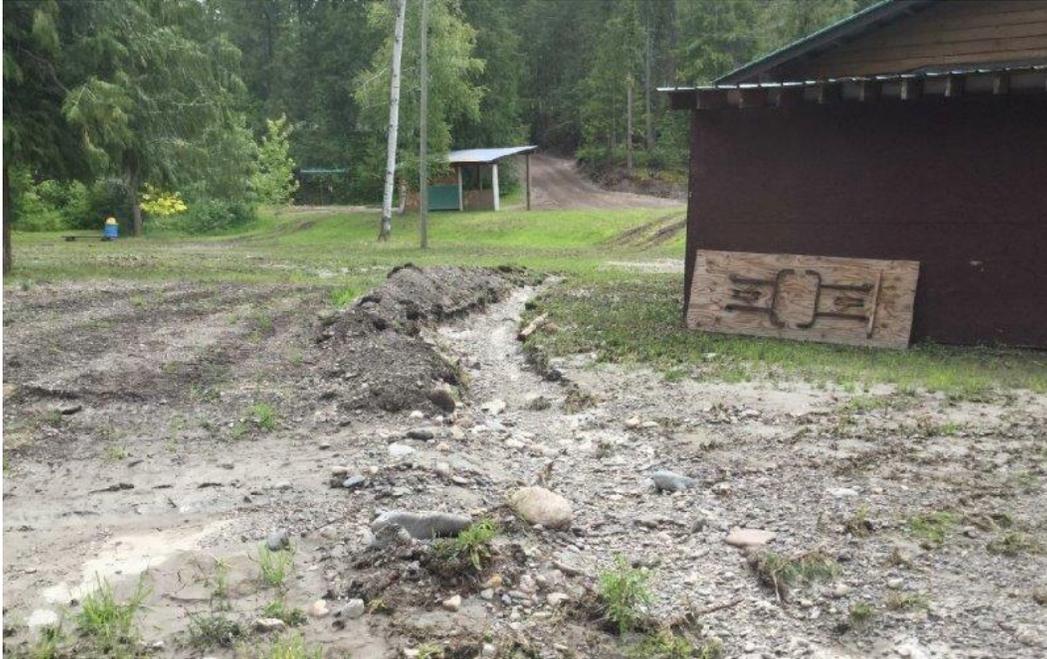
Photo 7 – Emergency ditching to divert flows away from buildings

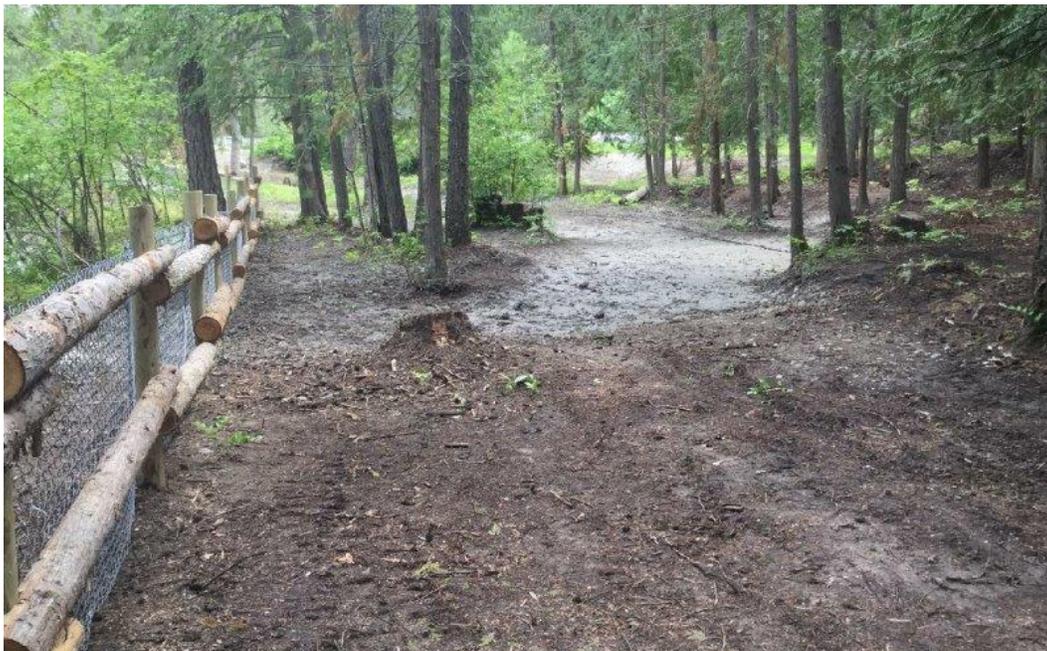
The flooding in May inundated most of the lower floodplain along the creek upstream of the campground and flooded through the campground (Photo 8). The central portion of the lower floodplain has been developed for recreation use and includes a stage, some concession stands, a covered, open dining area, a toilet and a picnic area. The high flows in the highwater channel that is immediately east of the stage and a concession stand, eroded the channel bank and was undermining the footings of the stage and the concession before the riprap was placed. There is damage to the foundations of both structures. There is also a well and water intake works west of the closed concession building that flooded but did not appear to have been damaged by the recent flooding.

Photo 8 – Evidence of flood flows through the campground

- The campground should be maintained as a primitive type campground that would have limited impacts from occasional flooding and only open for use after the spring freshet.
